### Early Implementation Project

July 30, 2009

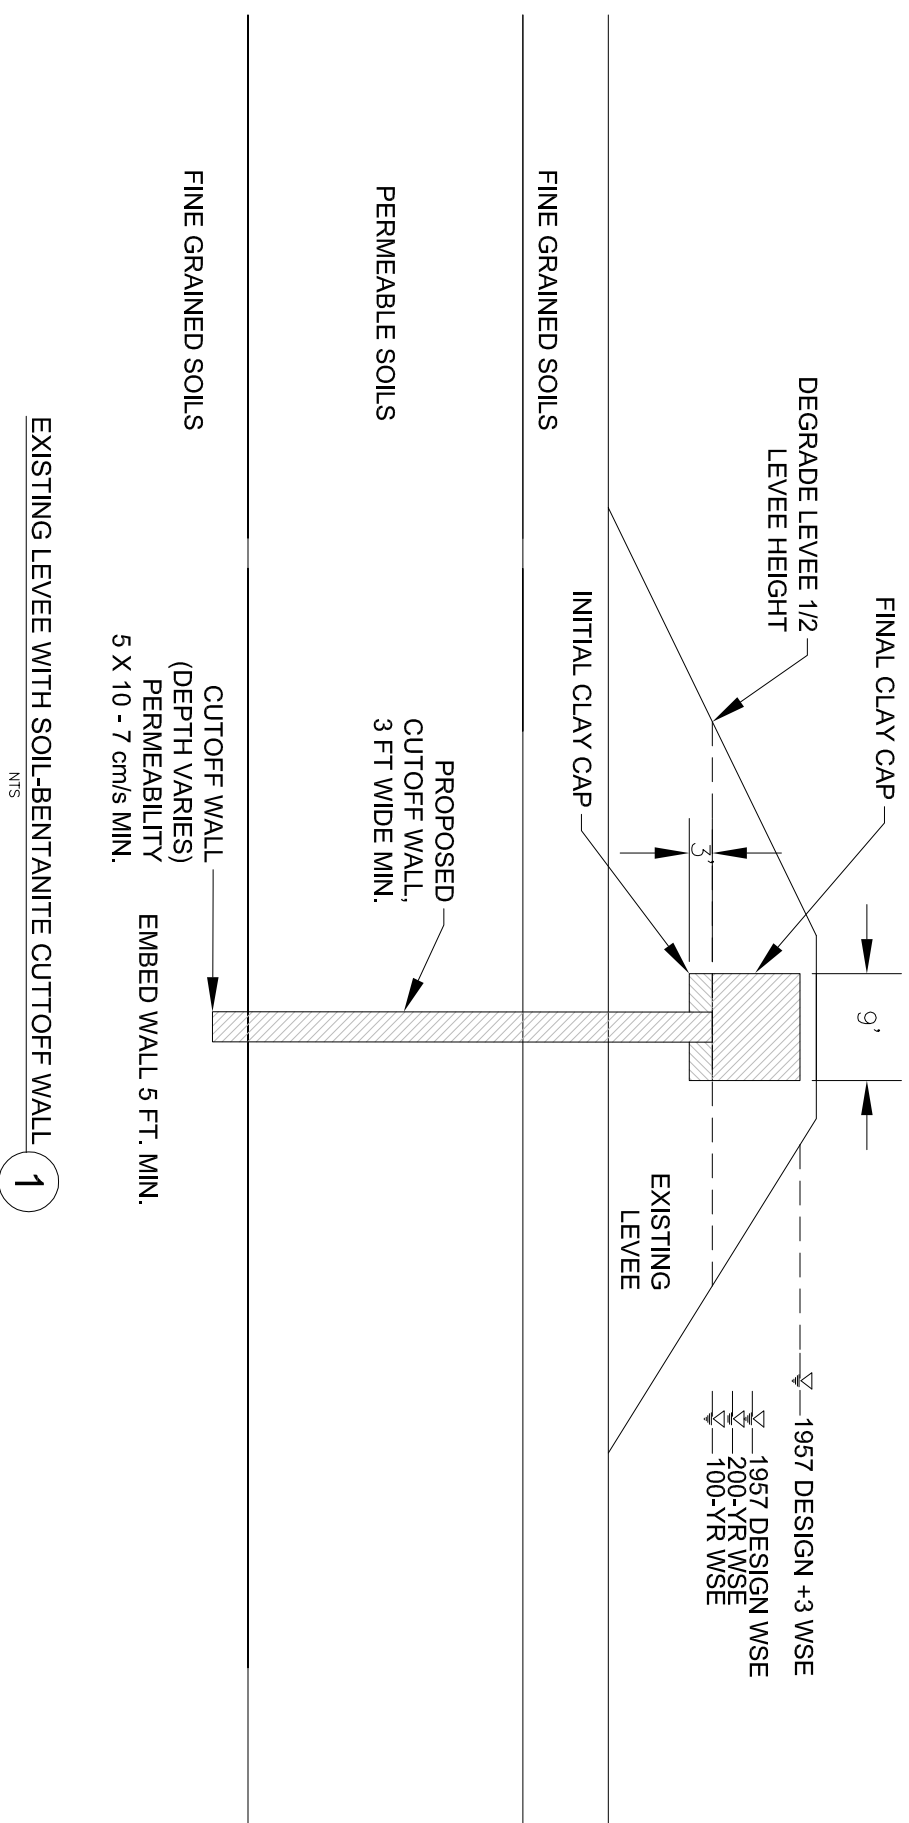
EXISTING LEVEE WITH SOIL-BENTONITE CUTOFF WALL 1  
NTS

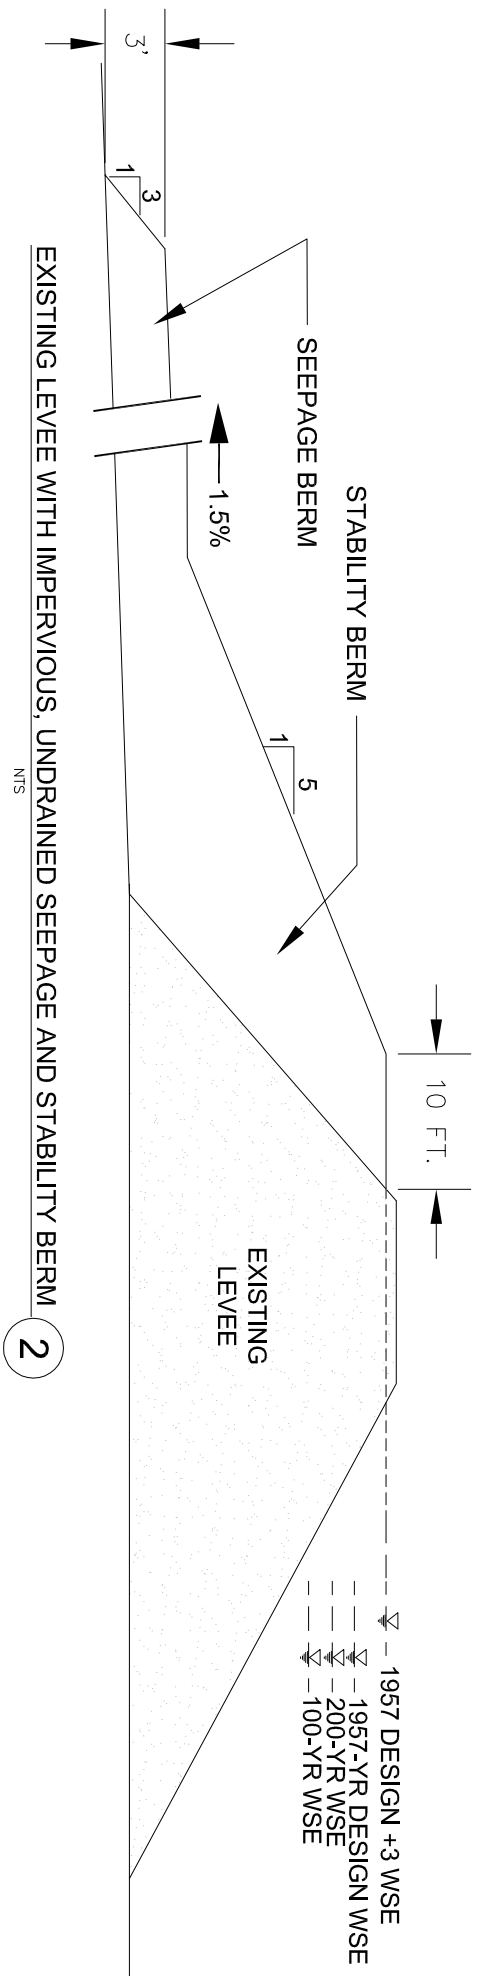
EXISTING LEVEE WITH IMPERVIOUS, UNDRAINED SEEPAGE AND STABILITY BERM 2  
NTS
